**NBSIR 76-1025**

# **Air-Mobility Rigid Shelter Systems**

An Interim Report

Prepared for  
**Air Force Civil Engineering Center**  
**Tyndall Air Force Base, Florida 32401**

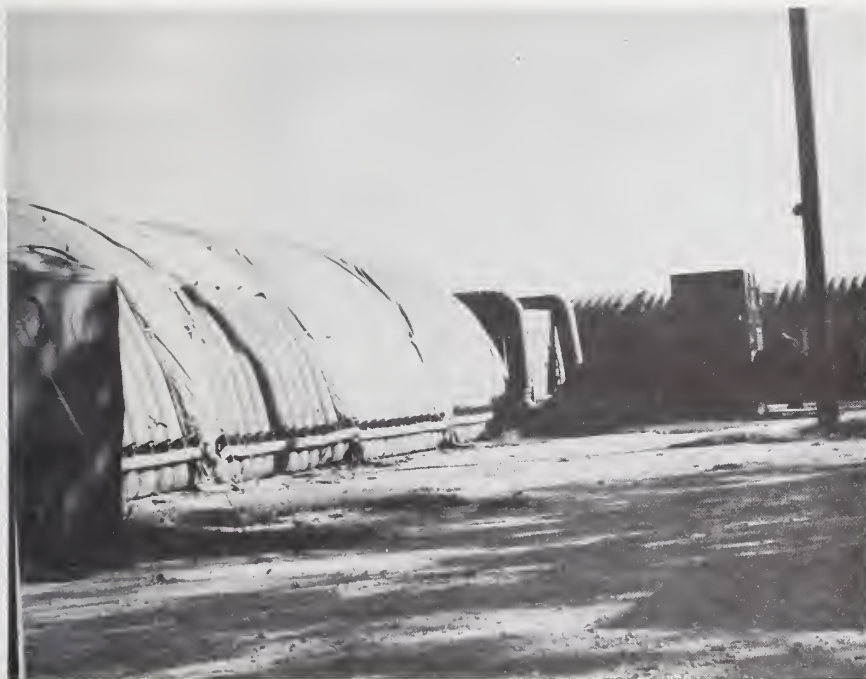
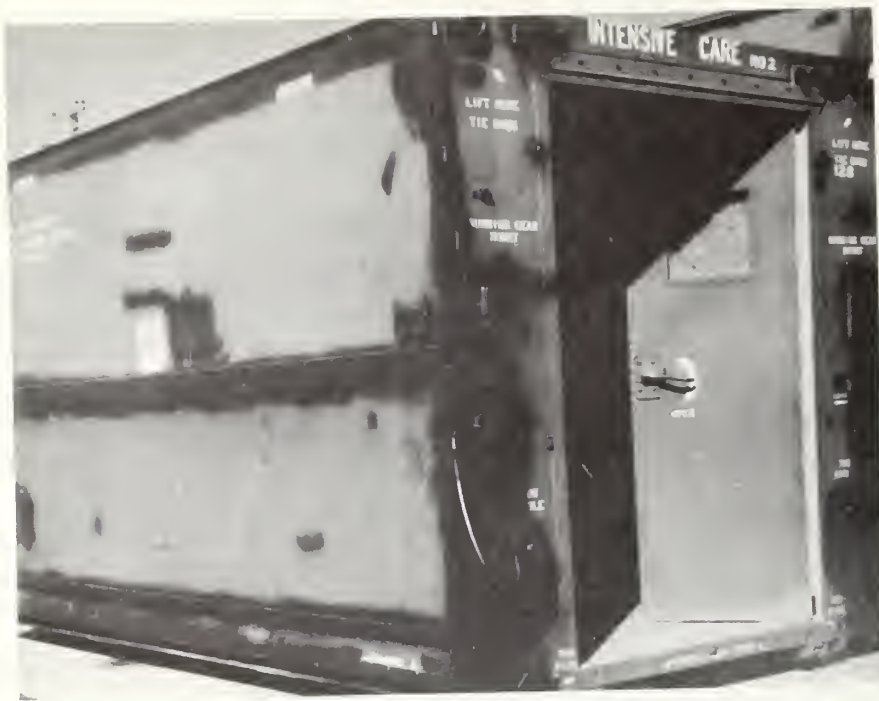
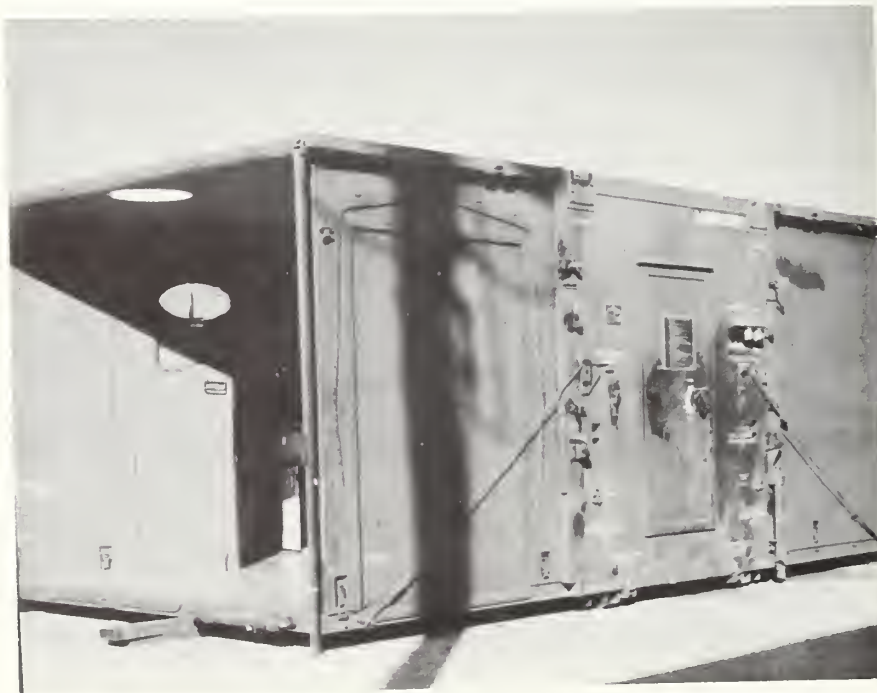
#### 2.4.3.3 MUST Shelters at Ft. Sam Houston (Figures 2.12, 2.13, and 2.14).

The maintenance personnel stated that all delaminated panels which they have repaired had water in them. The maintenance people also stated that their major repair work for these shelters was in three problem areas: (1) Panel delamination, (2) Failure of panels around inserts to which jacking-brackets are fastened (figure 2.34), and (3) Pole-brackets on the edge of the fold-up roof panel that had twisted loose and/or out of shape (figure 2.35a and 2.35b). They have "fixes" for these problems (figures 2.36a and 2.36b), but they felt that they are greatly handicapped in repairing delaminated areas because they cannot get new honeycomb except for the four small pieces in a repair kit that costs over \$1000.

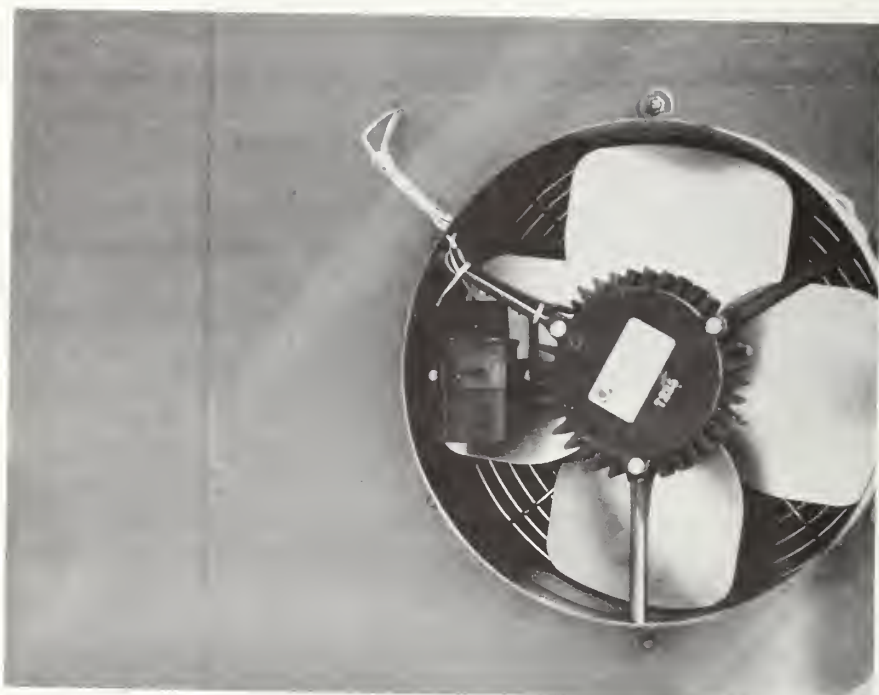
Fig. 2.31 Exhaust Fan Unit - New ES/C

The only obvious fault on this shelter was in the installation of the exhaust fan unit. This unit can be seen in figure 2.31 with the wires and starting condenser of the fan unit exposed to the weather.

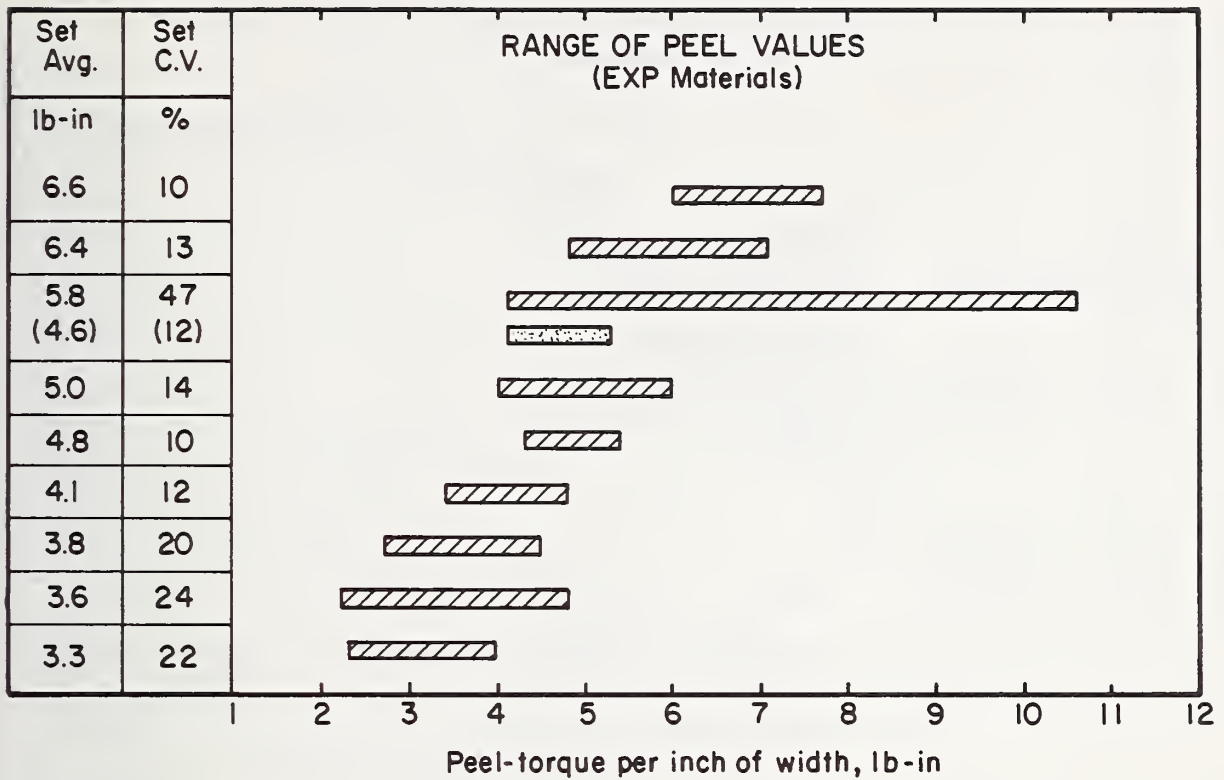
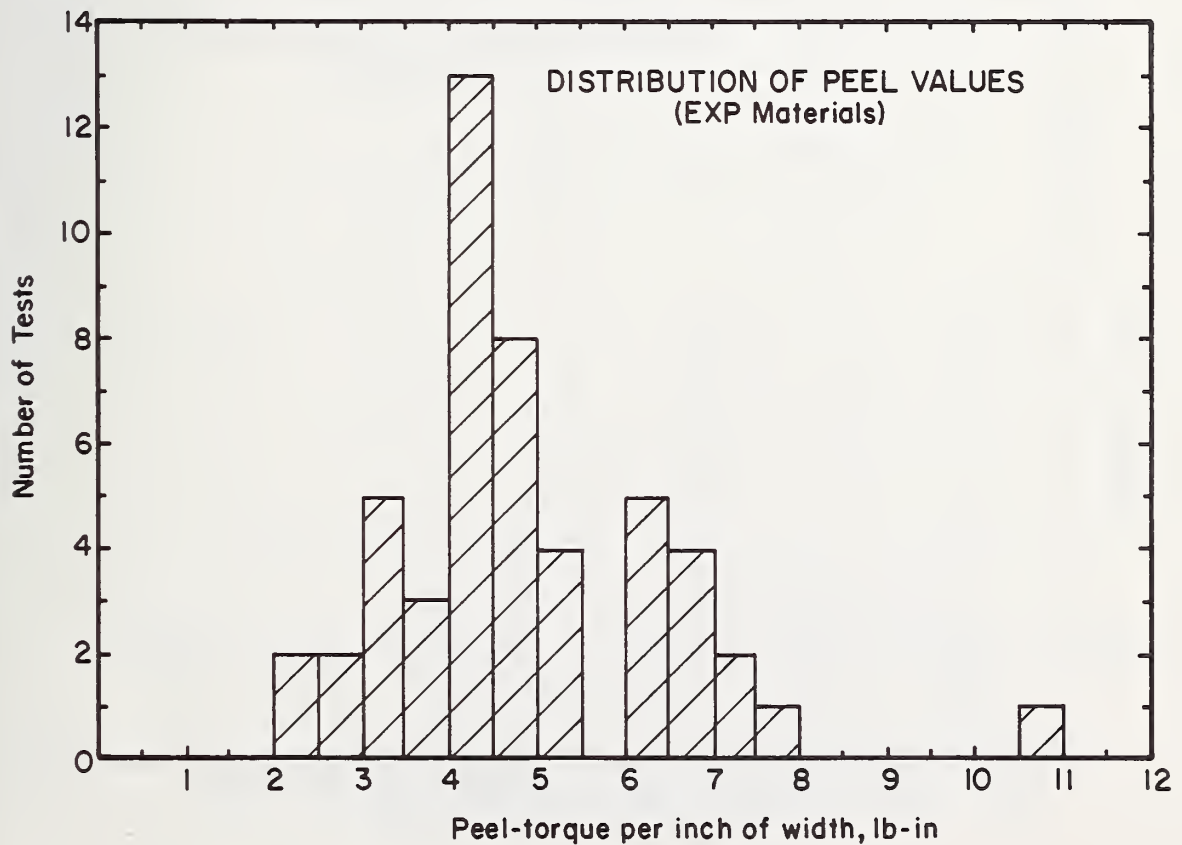
Fig. 3.19 Distribution and range of individual values for peel tests on EXP panel material

A summary of the peel test results for the honeycomb panel specimens is given in table 3.1. The range and distribution of the individual test values are shown on figure 3.19. Table 3.2 lists the individual test values determined on the facing materials. The data of table 3.2 points out the necessity of measuring the bending load on actual facings when evaluating peel strength of the bond.

One peel test specimen gave an abnormally high value (10.6 in-lb/in). Close inspection of this specimen revealed that it had a double-thickness of adhesive over most of its area. This specimen is included in the table 3.1 and figure 3.19 data for the set with an average of 5.8 lb-in. The average for this set with the abnormal value deleted was 4.6 lb-in. as indicated by parenthesis in table 3.1.

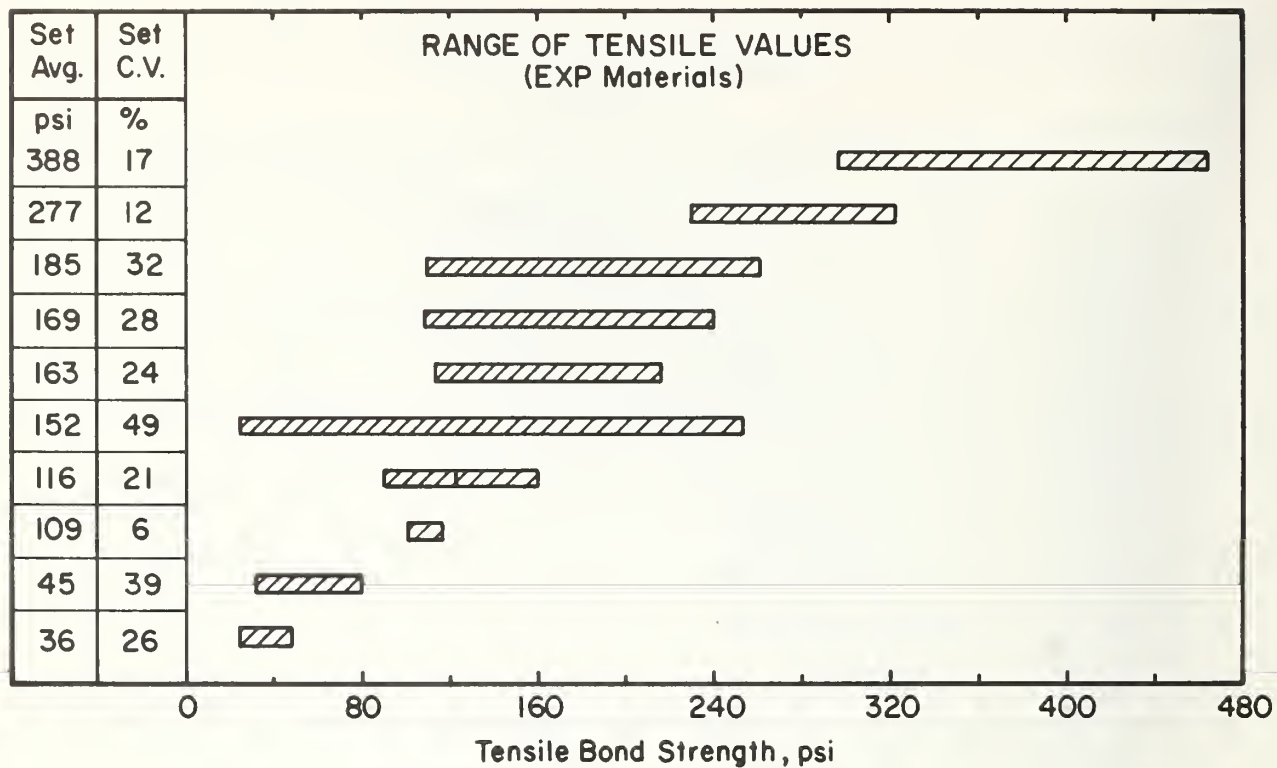
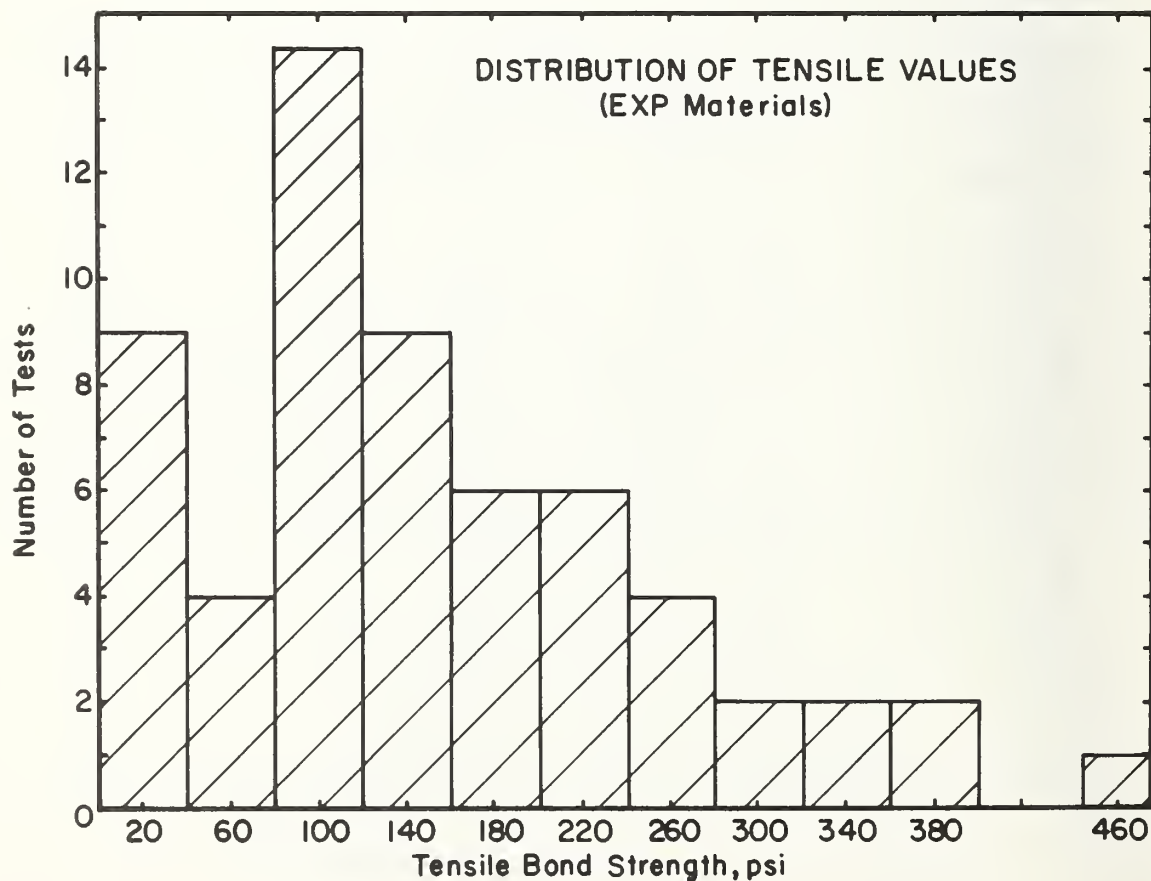
Fig. 3.20 Distribution and range of individual values for tensile tests on EXP panel material

The range and distribution of the individual test values are shown in figure 3.20.

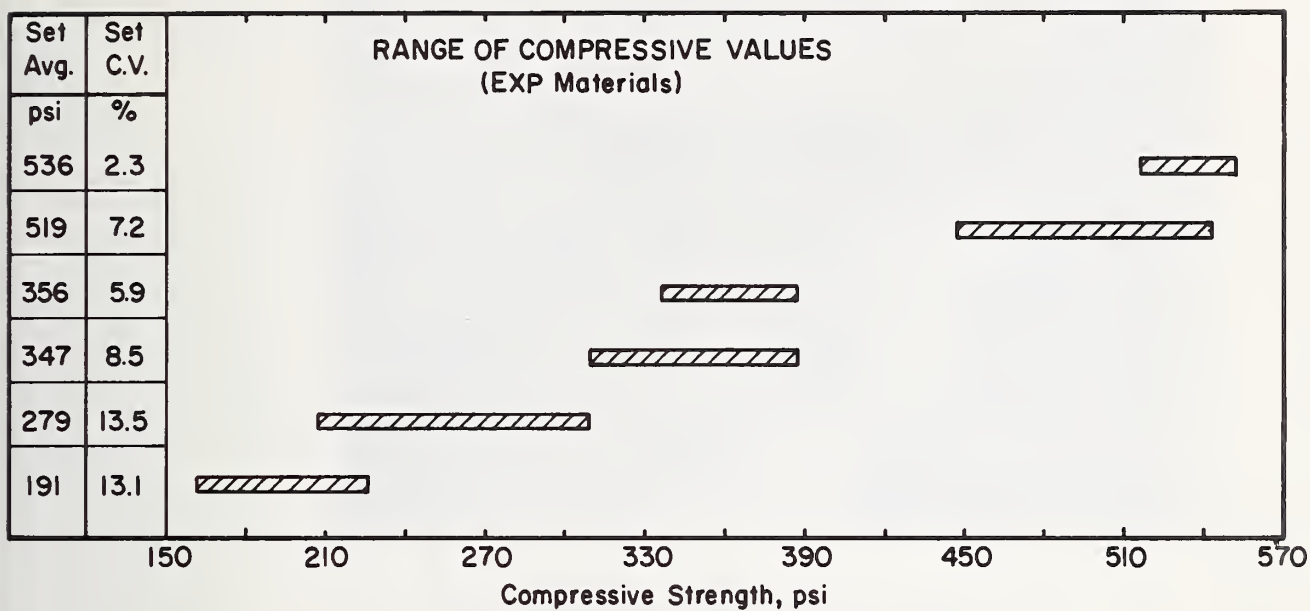
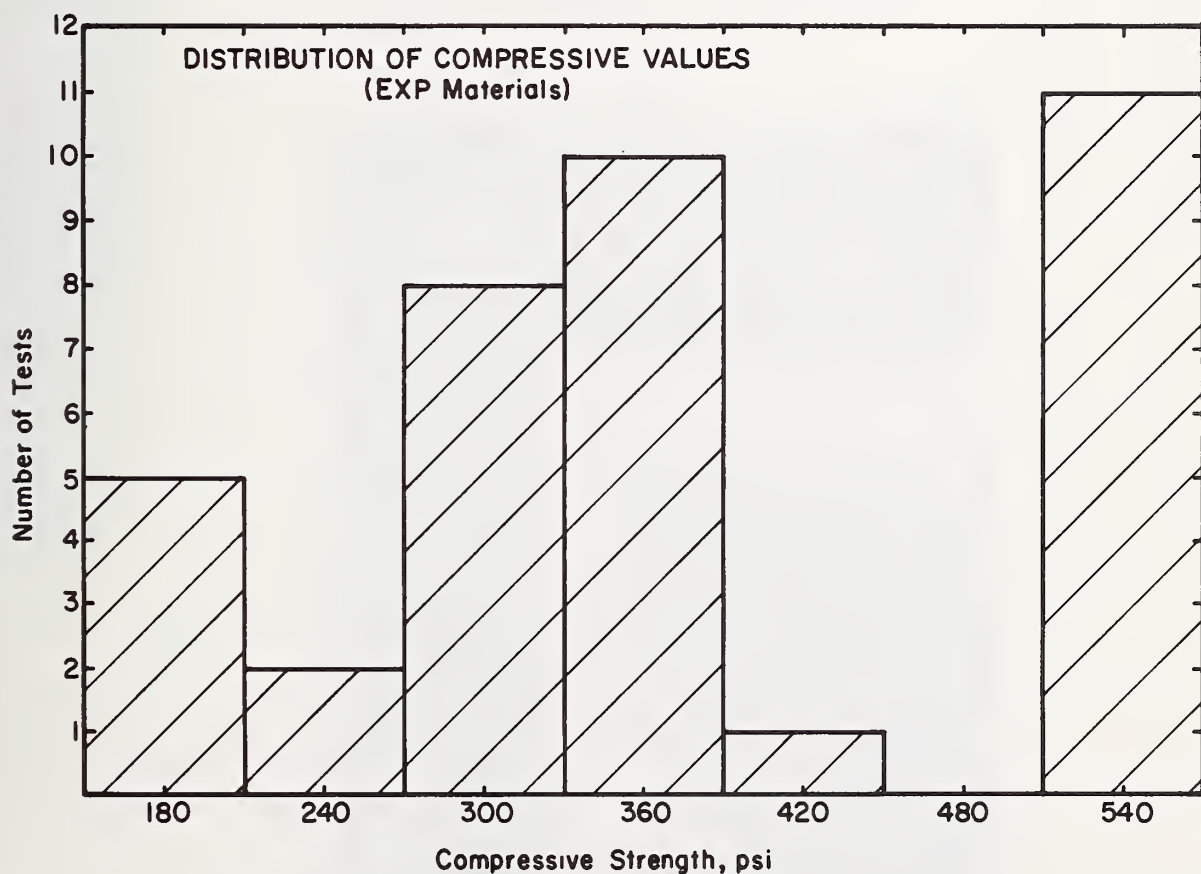
Fig. 3.21 Distribution and range of individual values for compressive tests on EXP panel material

The summary for the compressive test results on honeycomb specimens is given in table 3.4, and the range in individual values is indicated in figure 3.21. The purpose of these tests was to determine the effect of long-term exposure to water on the strength properties of the honeycomb. The honeycomb of panel 15R looked like new while much of the honeycomb in panel 14R was water-logged, was very dark brown, and looked as if it may have deteriorated. All tests were performed at 73°F.

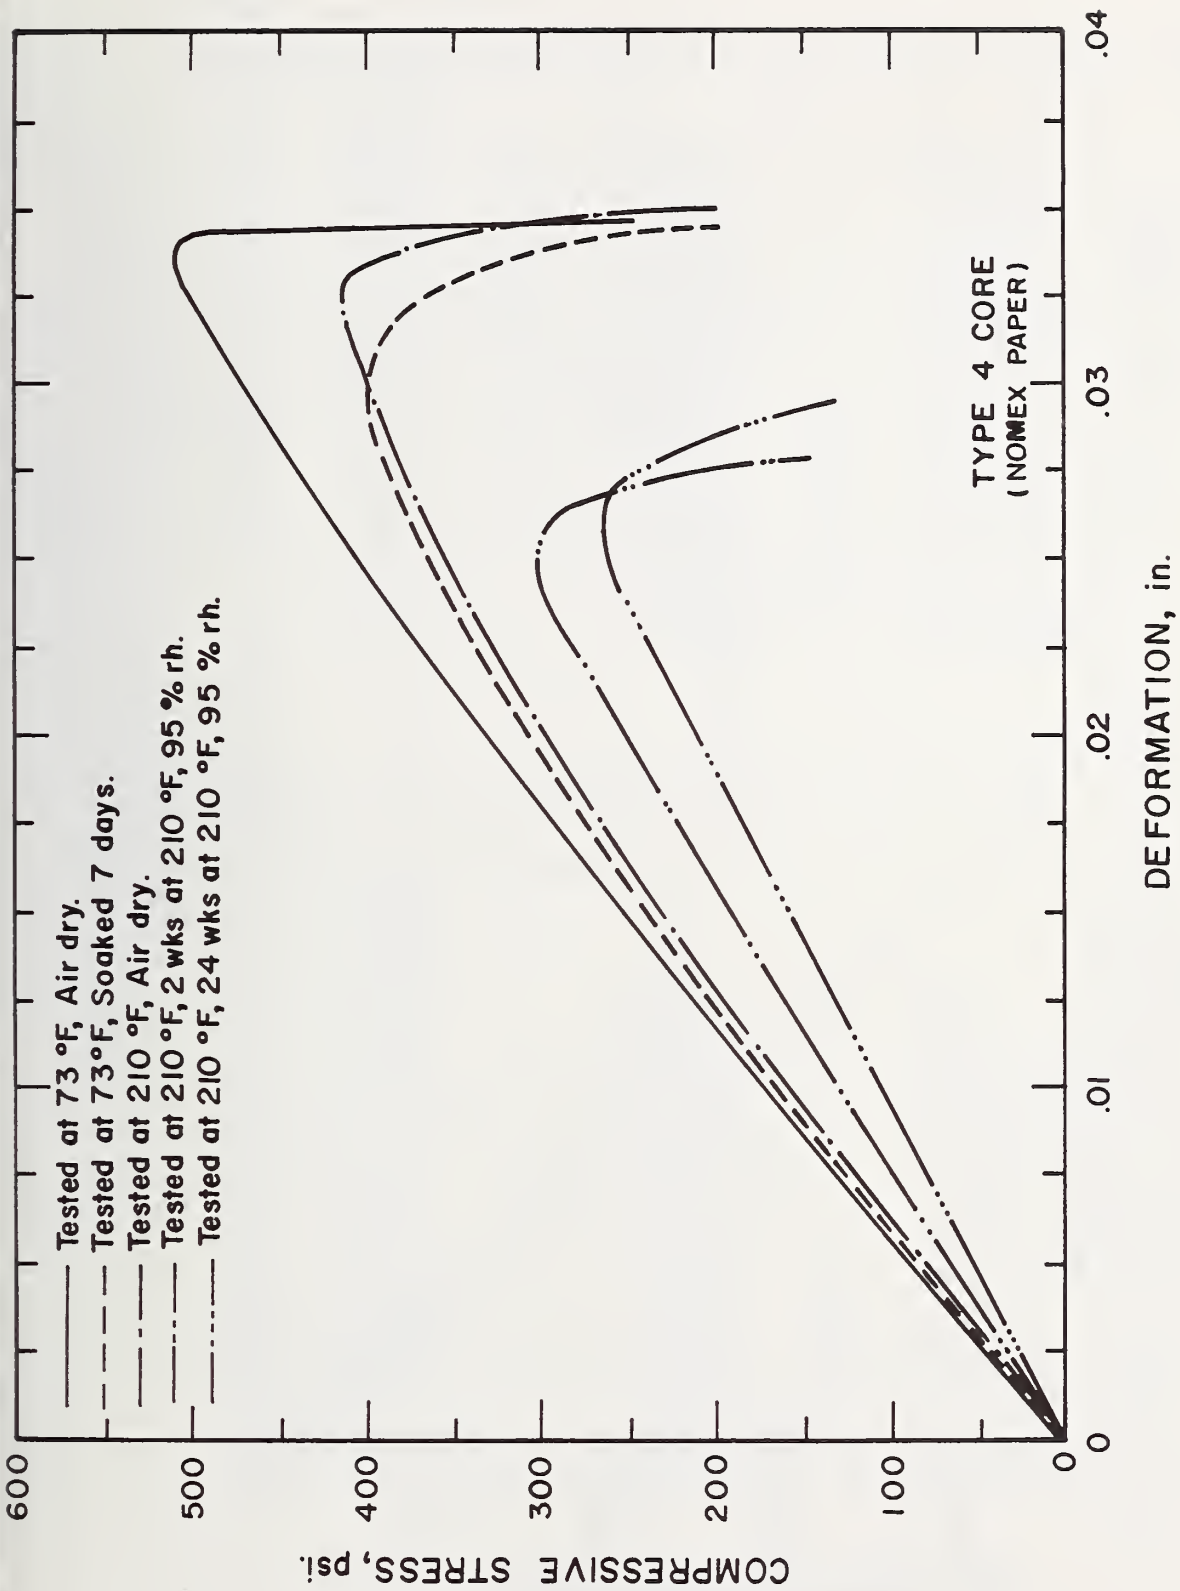
Fig. 4.1 Average stress-deformation data  
for sets of Type 4 Core specimens

Average test results for each conditioning procedure are presented in table 4.2. Average stress-deformation data for sets of Type 4 and 6 core specimens are shown in figures 4.1 and 4.2.

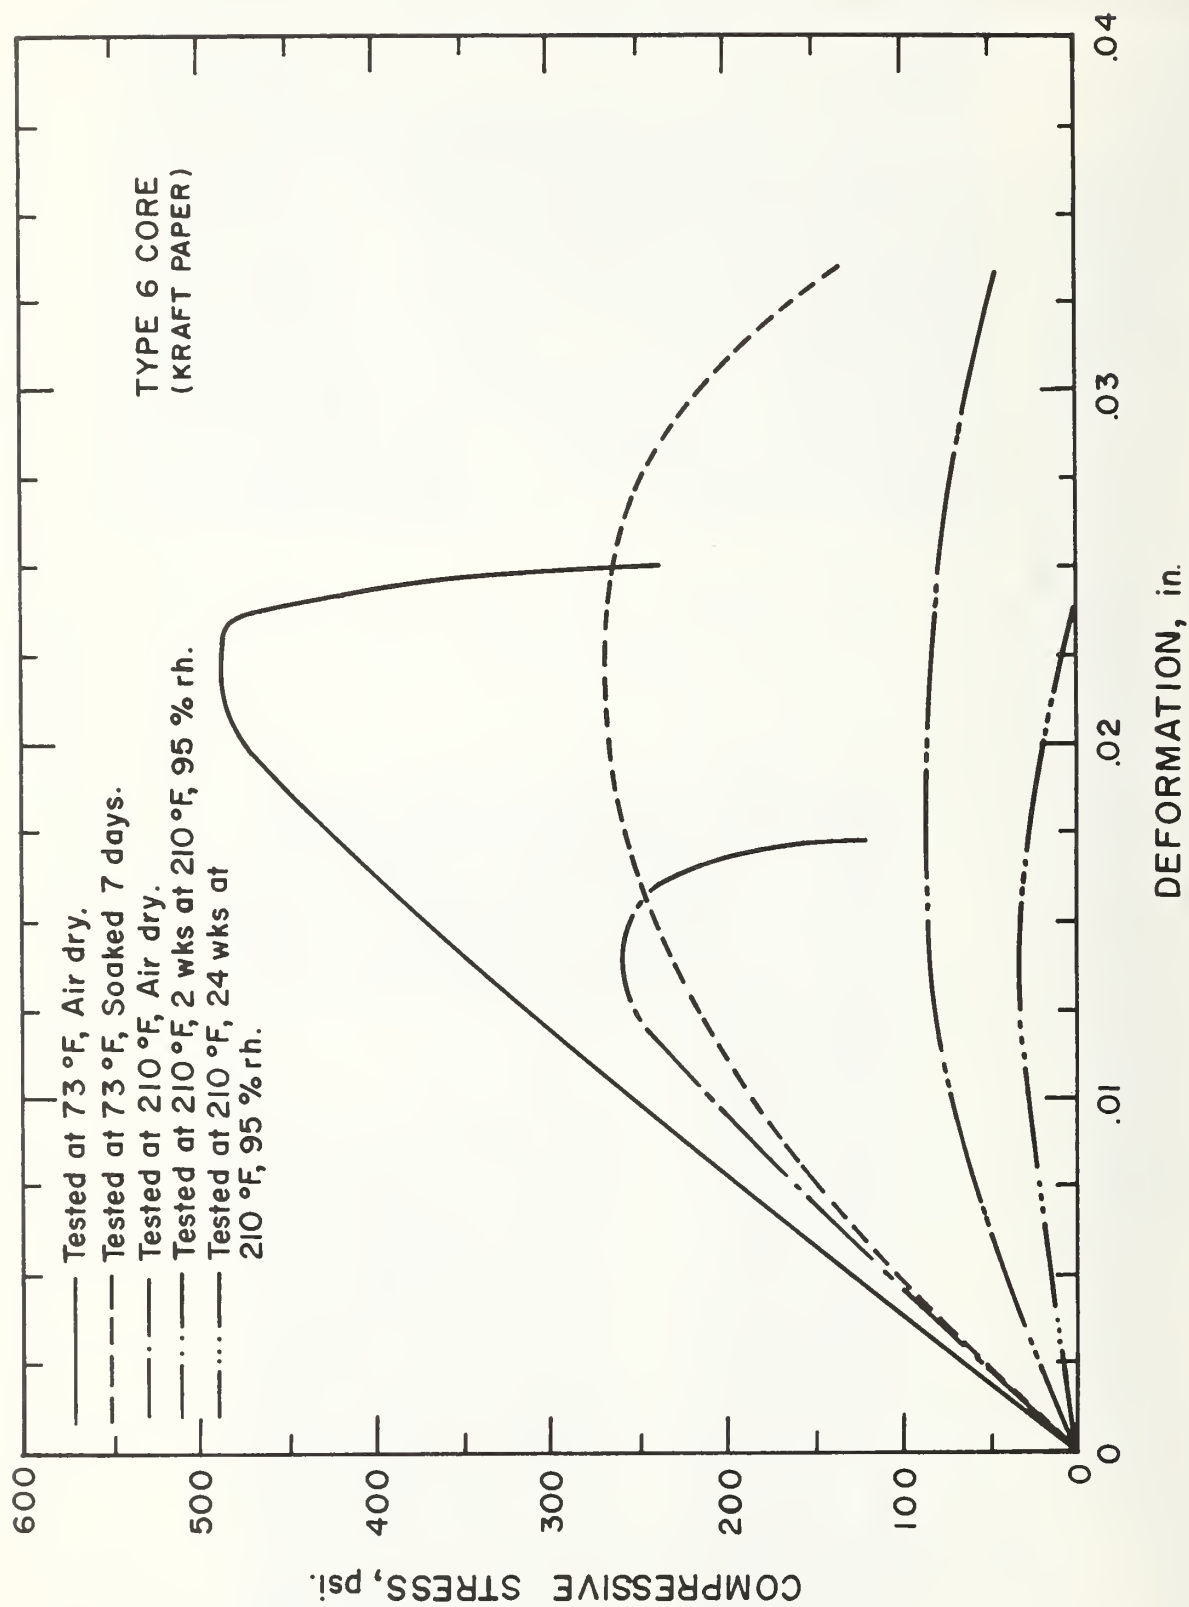
Fig. 4.2 Average stress-deformation data for sets of Type 6 Core specimens

2. Using the relative strength values of table 4.5, the average Nomex core performed better than the WR II by factors as great as 8.3.
3. The strength of the WR II core was too low to have practical value after 24 weeks exposure to high humidity and either 180°F or 210°F. (See table 4.2 or 4.5 and figure 4.2 or 4.3.)

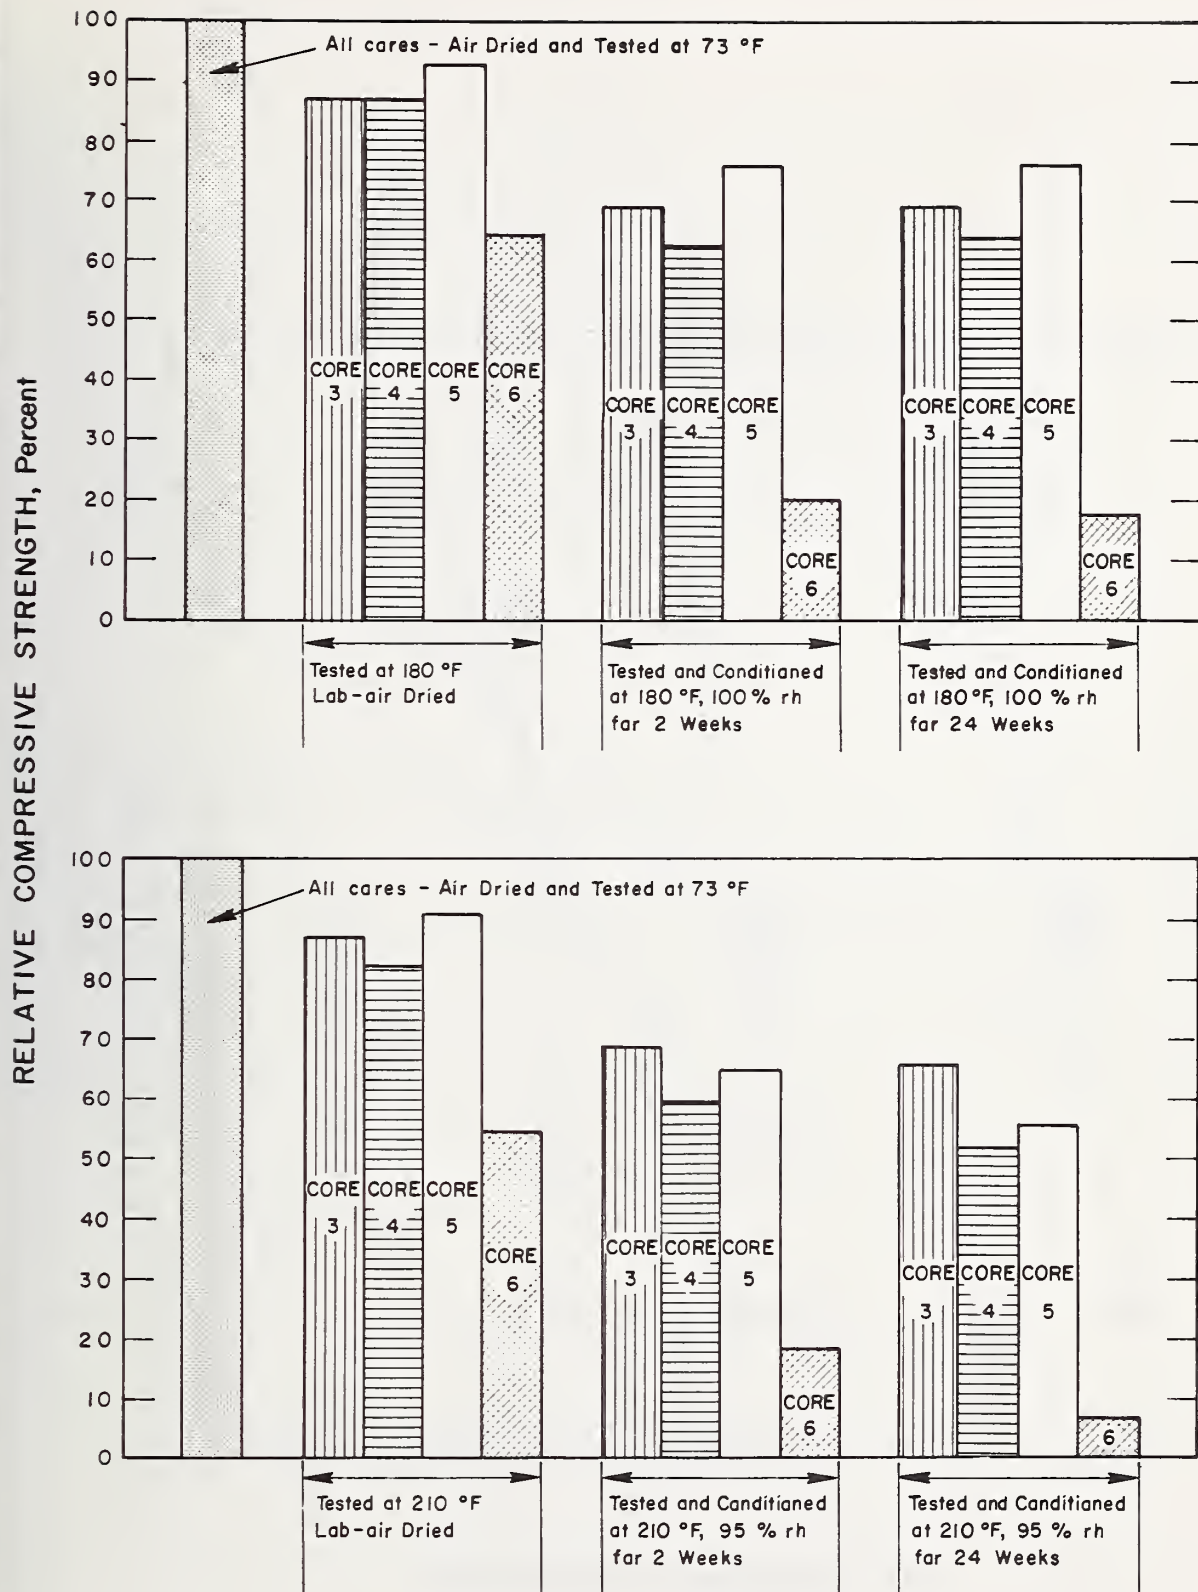
Fig. 4.3 Effect of the conditioning method on the relative strength for the four types of core

The effect of conditioning on strength is shown graphically on figure 4.3 and in table 4.5.

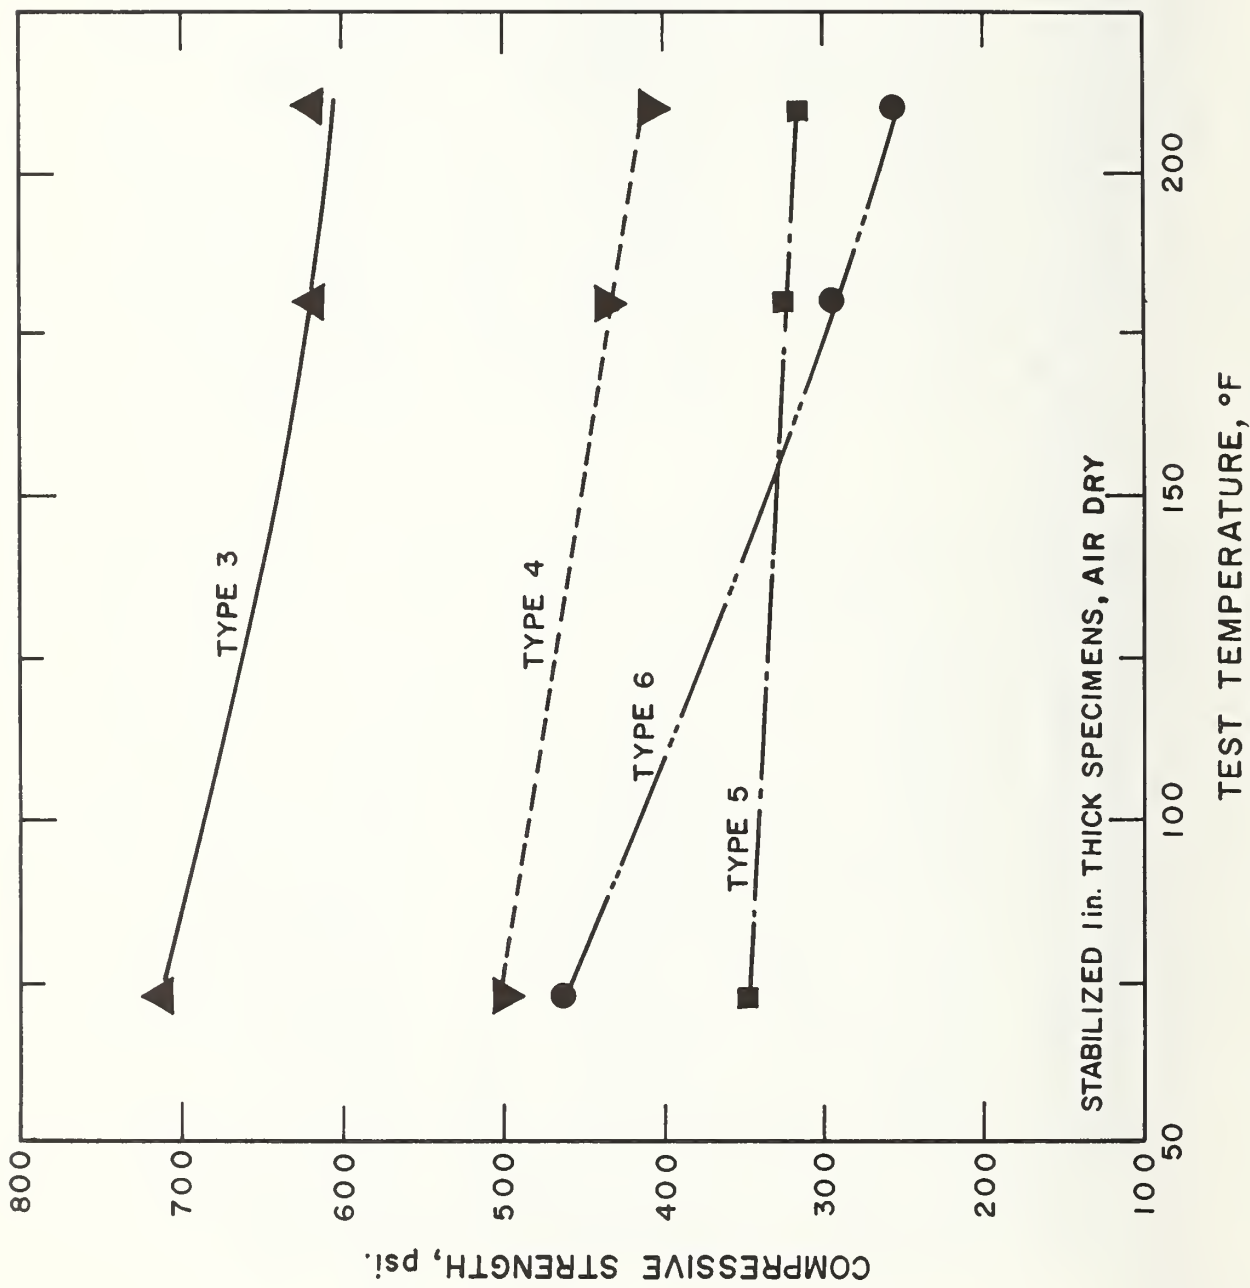
Fig. 4.4 Effect of test temperature on compressive strength for the four types of core

Figure 4.4 indicates the effect of temperature on the strength of air dried specimens. Figure 4.5 shows the effect of temperature on the strength-density relationship.

1. The compressive strengths of the four honeycomb cores varied inversely with the test temperature. (See figure 4.4.) However, the loss in strength for the WR II was about three times greater than for the Nomex cores when the temperature was changed from 73°F to 210°F.

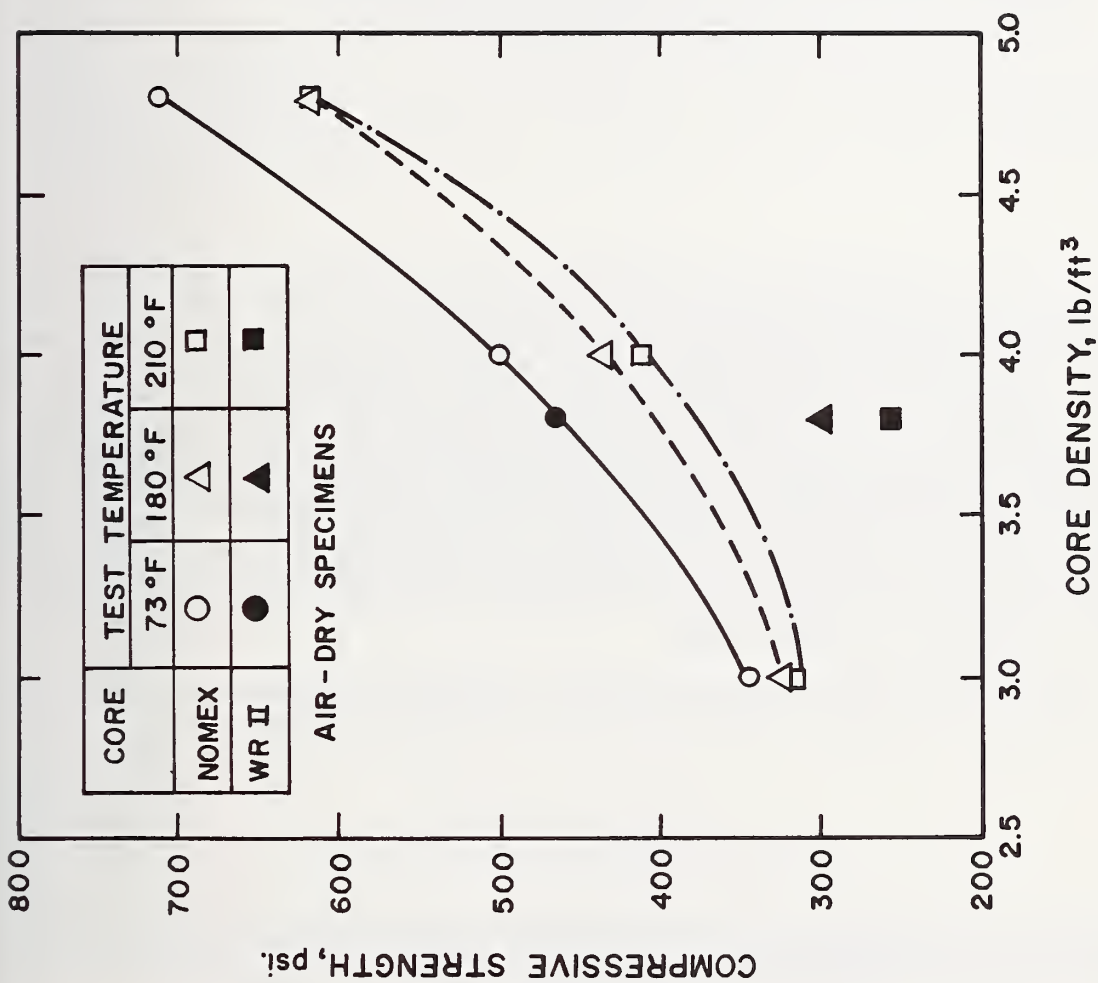
Fig. 4.5 Effect of core density on the compressive strength for the four types of core at various temperatures.

5. The compressive strength of all four cores, in the air-dry condition and at 73°F, are roughly proportional to their air-dry density. (See figure 4.5.) However, at 180°F and 210°F test temperatures, the strength to density ratios for the WR II core are much lower than those for Nomex cores.
